Roof Analysis Report

City of San Bruno
567 El Camino Real
San Bruno, CA 94066

Library
San Bruno, CA

October 27, 2021

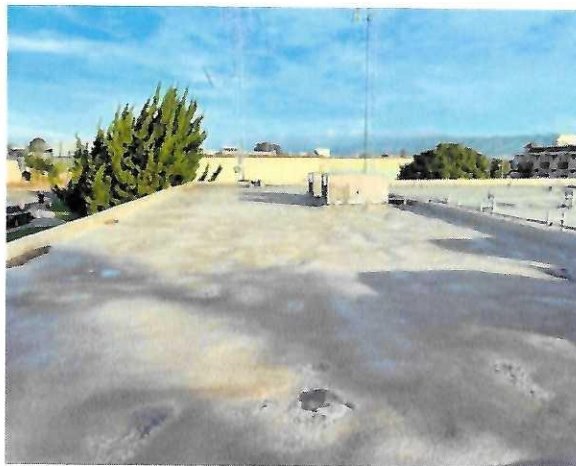
1. Overview of the roof.

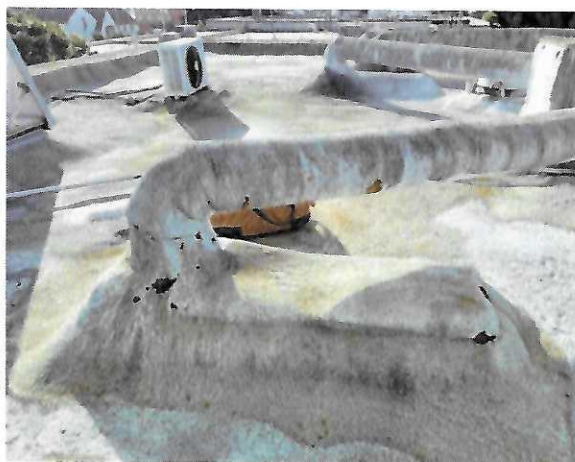
2. Close-up photo of isolated areas of failure.

1. 3-course the damaged areas of the roof using AlphaGuard MT + Permafab.
2. 3-course damaged perimeters using Alphaguard MT + Permafab.

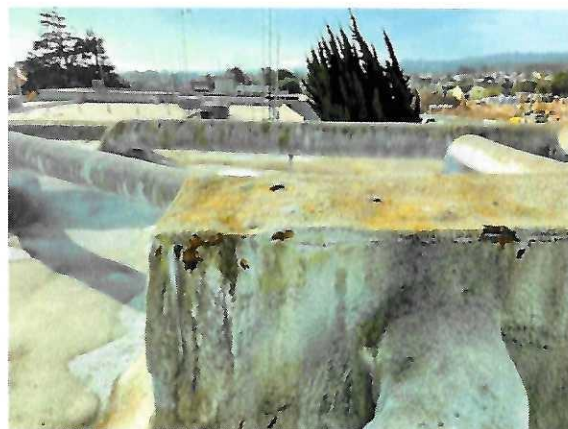
3. Close-up photo of SPUF failure.

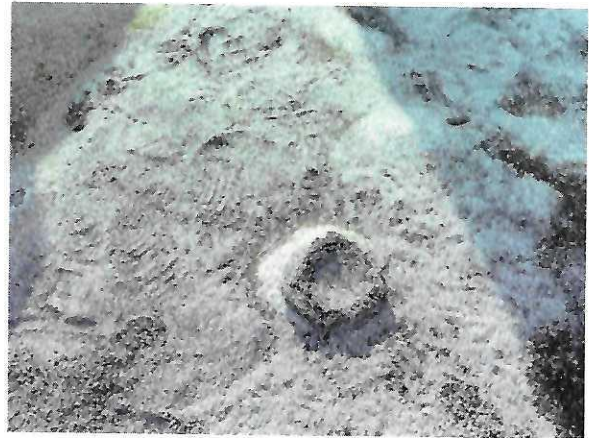
4. Close-up photo of granules collecting on the roof. As granules become loose, the membrane is no longer protected.

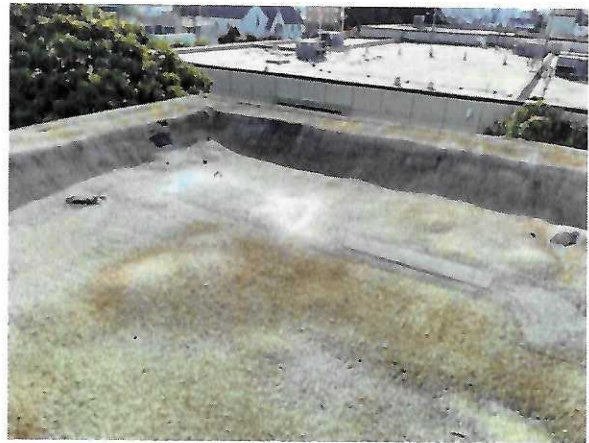
5. Close-up photo of blisters/previous repairs.

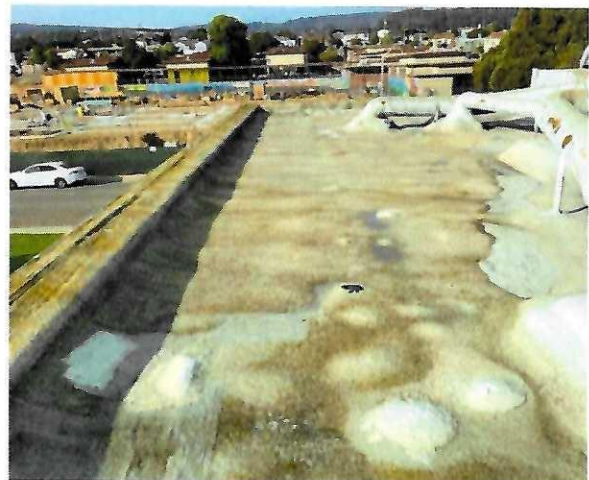
6. Close-up photo of several blisters and repairs.

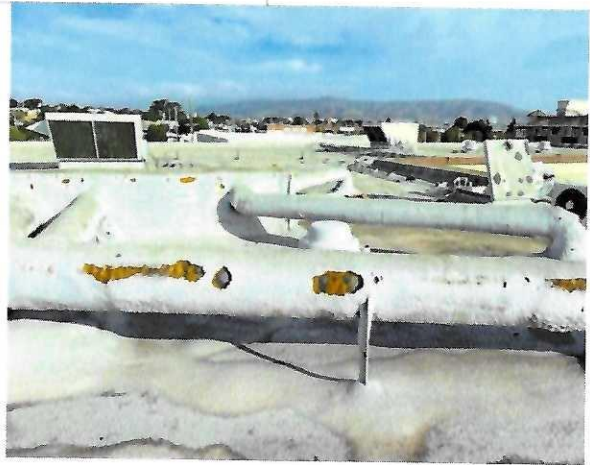
7. Openings in the ductwork.

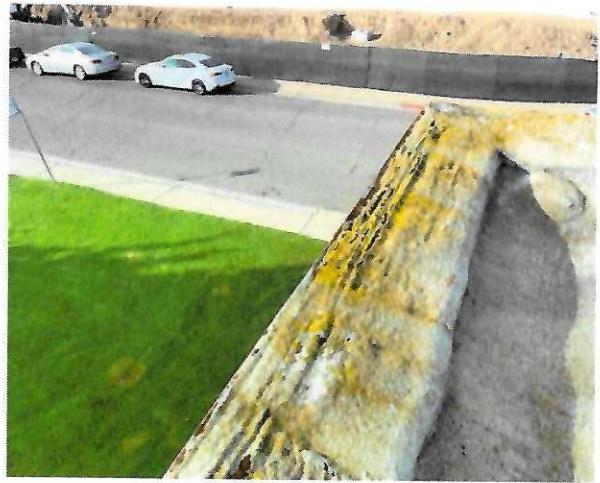
8. Close-up photo of openings along the perimeter.

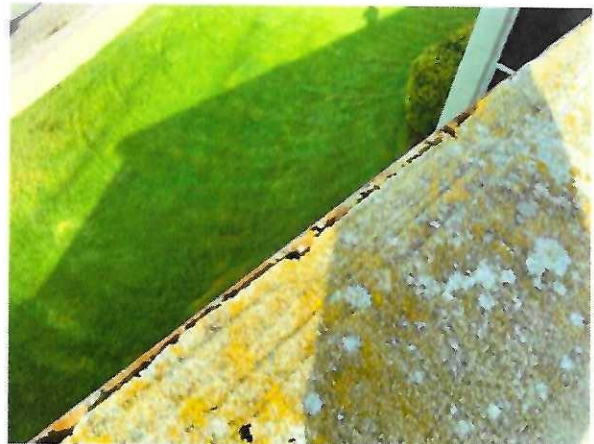
9. Close-up photo of damage to the perimeter of the roof.

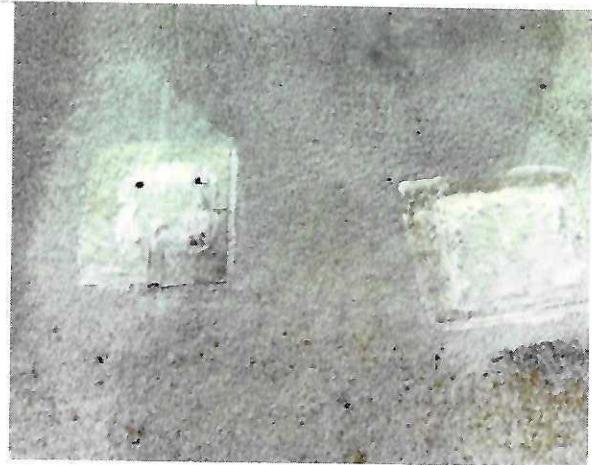
10. Close-up photo of previous repairs made to the roof.

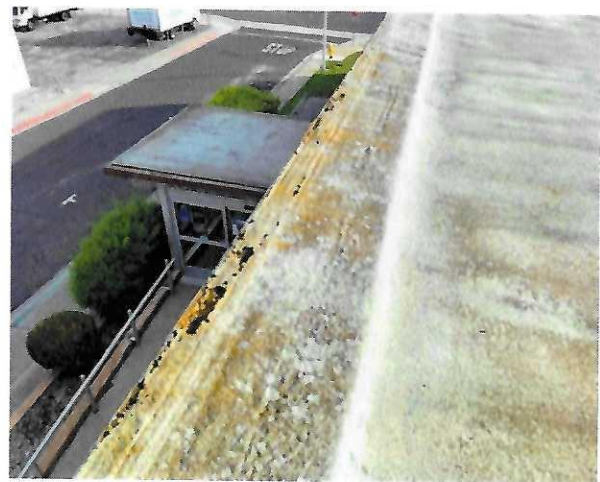
11. Close-up photo of failure at the perimeter of the roof.

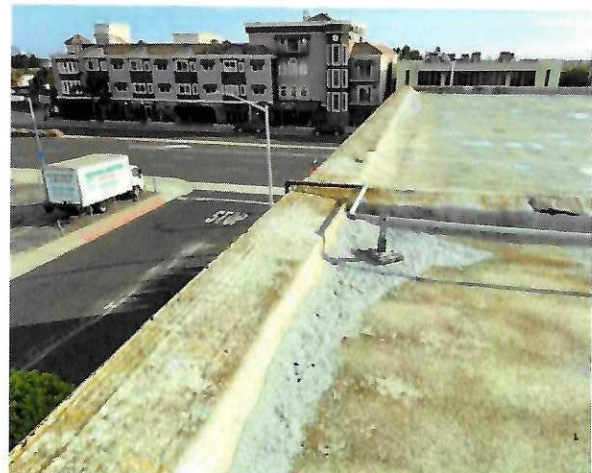
12. Close-up photo of granules collecting in the corners of the roof.

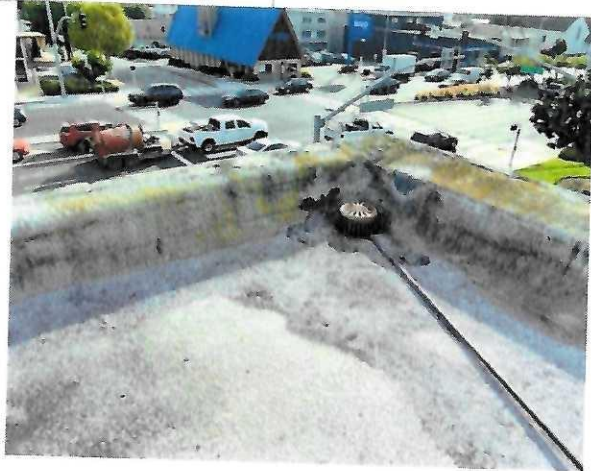
13. Photo of granule collection.

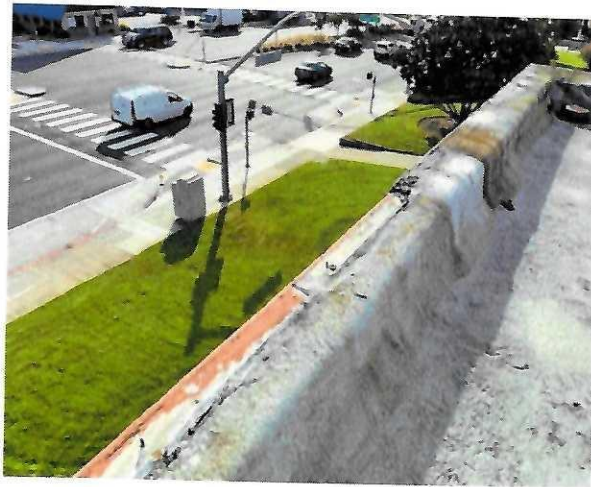
14. Damaged perimeter.

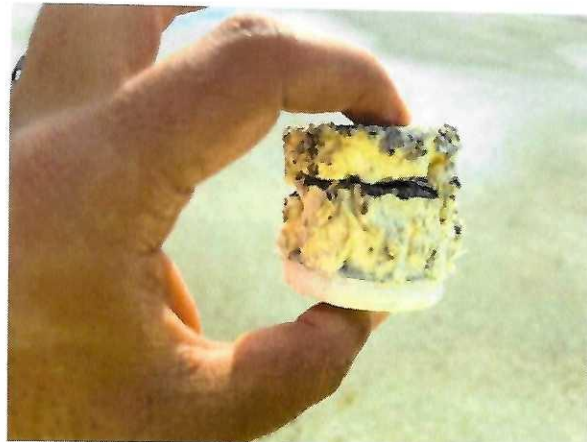
15. Close-up photo of a core sample.
